Test report no. 173385

1st copy of 03rd July 2017

Subject of commission: Testing of Impact resistance according to ETAG 034

Cembrit Patina 8 mm

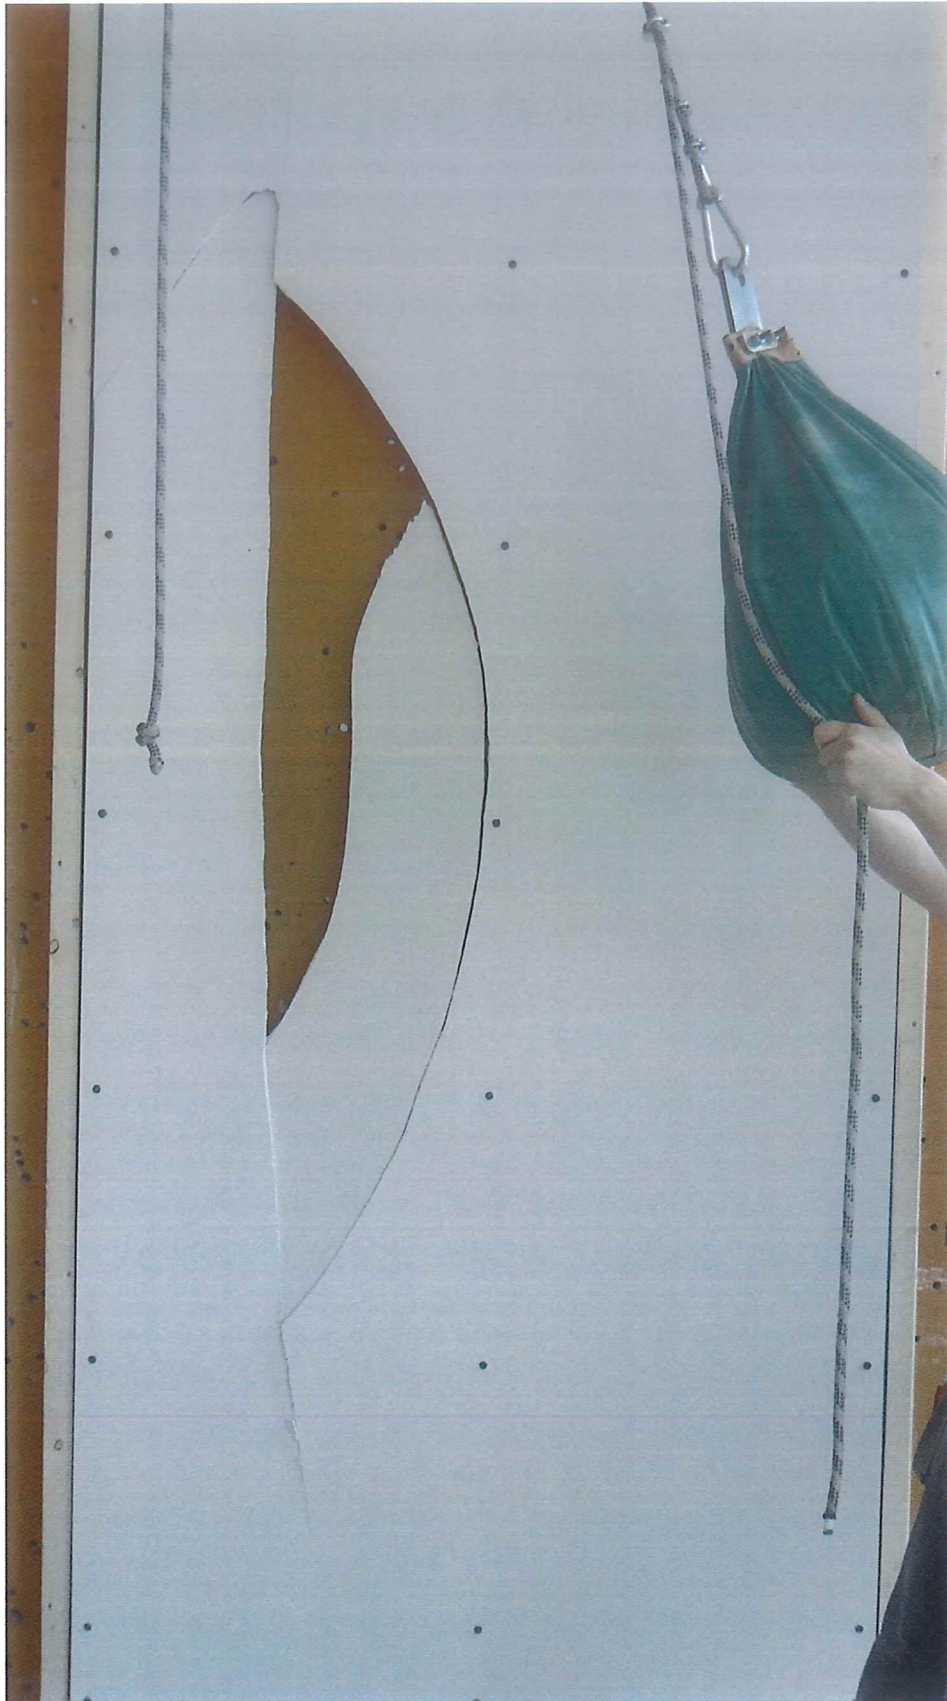
Appendix A3: Failure, soft ball 50 kg with 300 Joule

Period of testing: 15.05.2017 to 16.06.2017						
Type of impact	Type of ball	Mass	Energy	Height	Position	Observation
Hard body	Steel ball	0,5 kg	1 Joule	0,20 m	3 locations	no damage
	Steel ball	0,5 kg	3 Joule	0,61 m	3 locations	no damage
	Steel ball	1,0 kg	10 Joule	1,02 m	3 locations	no damage
Soft body	Soft ball	3,0 kg	10 Joule	0,34 m	3 locations	no damage
	Soft ball	3,0 kg	60 Joule	2,04 m	3 locations	no damage
	Soft ball	50,0 kg	300 Joule	0,61 m	At least in the centre point	broken, deterioration
	Soft ball	50,0 kg	400 Joule	0,82 m	At least in the centre point	not tested

Type of impact	Energy	Category IV	Category III	Category II	Category I
Hard body	1 Joule	passed	-----	-----	-----
	3 Joule	-----	passed	passed	passed
	10 Joule	-----	-----	passed	passed
Soft body	10 Joule	passed	passed	-----	-----
	60 Joule	-----	-----	passed	passed
	300 Joule	-----	-----	not passed	-----
	400 Joule	-----	-----	-----	not passed
Evaluation		passed	passed	not passed	not passed
